MEMO TO FILE

The following information, Photos, has been separated from the rest of the original documents belonging to site, Bath Elec Systems (BES) ID # TXD065103327, because the material could not be stored at the Federal Records Center due to certain storage restrictions.

TDD# 06-8590-98 Pg. 1 of 20

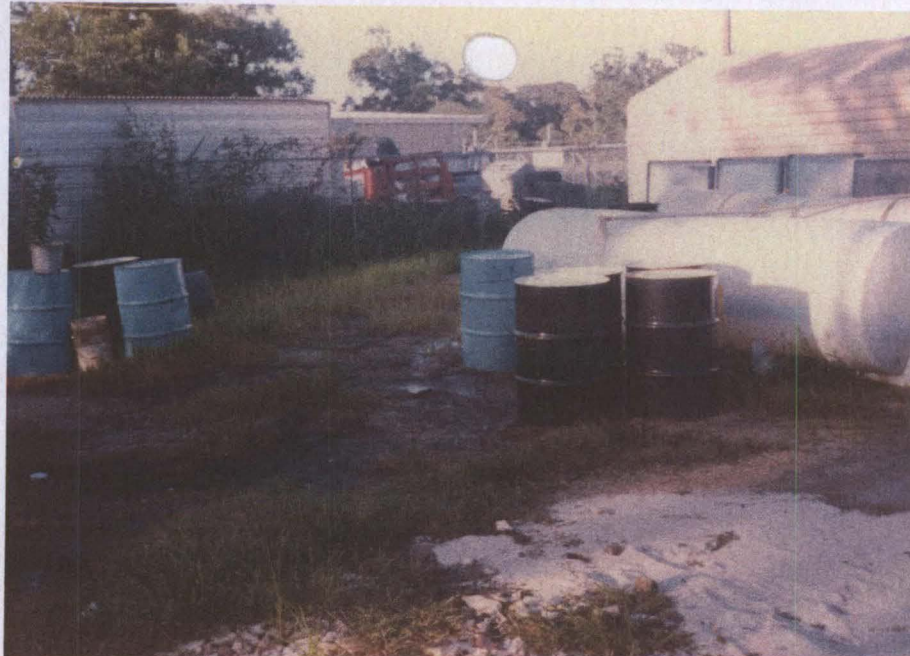
Photographer/Witness # 4

Comments: Condition of soil at
tanks from which release occurred.

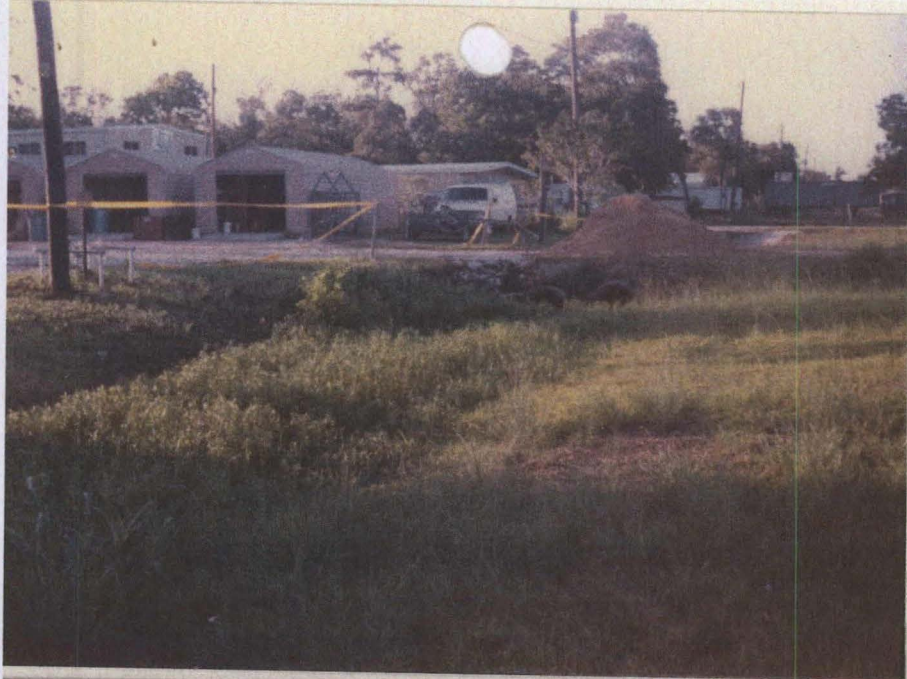
Photographer/Witness # 7

Comments: Contaminated ditch to
north

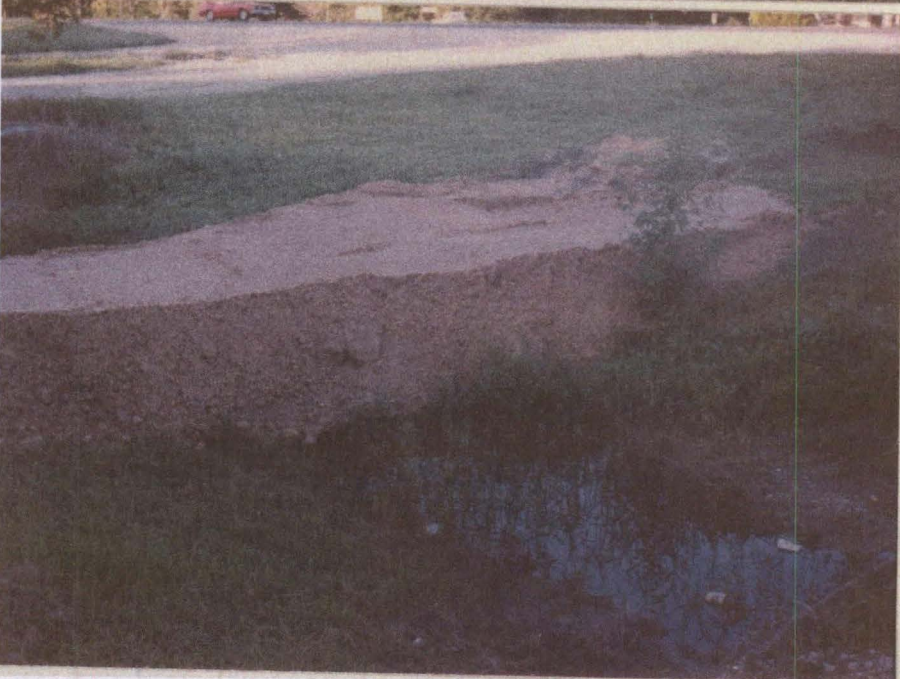
Photographer/Witness # 8

Comments: PCB oil in culvert.
Seven culverts were located within
the affected section of ditch

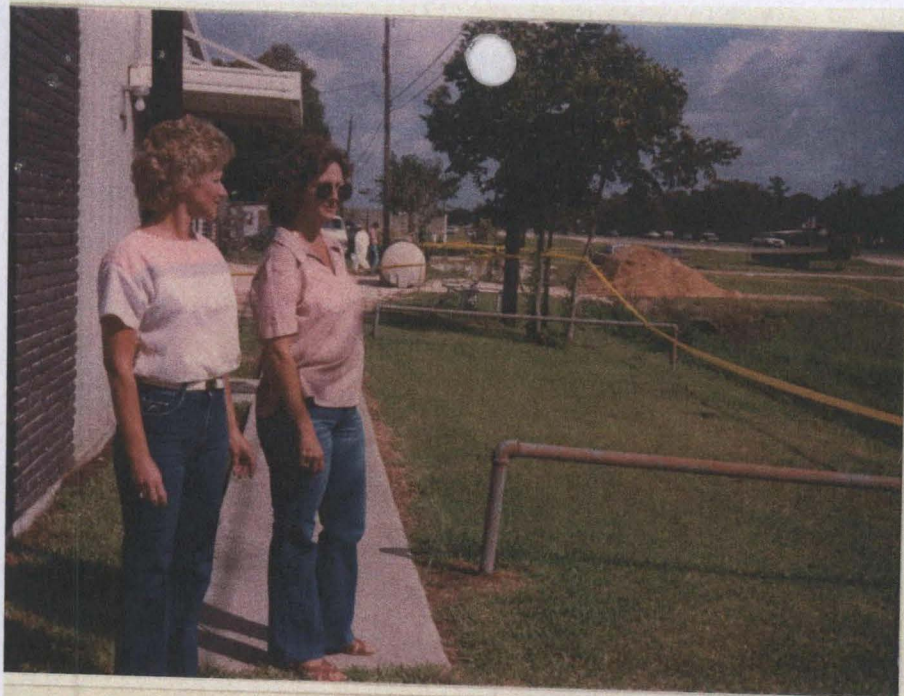
Photographer/Witness # 10

Comments: A view of the PCB contaminated ditch with yellow tape. In the background, vacuuming of contaminated water from the ditch is in progress

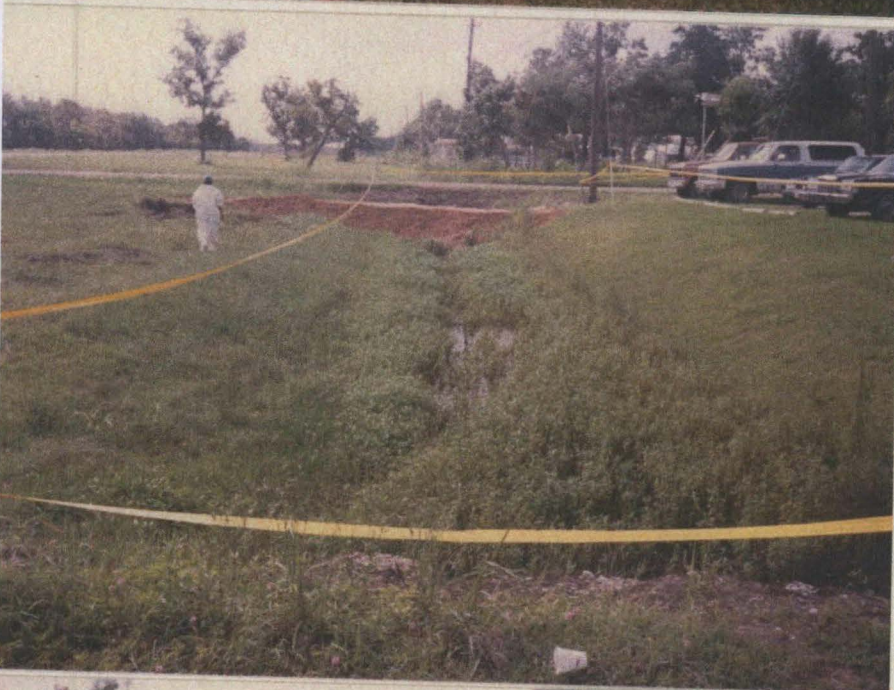
Photographer/Witness # 11

Comments: A view of the southern half of the PCB contaminated ditch. An earlier dike shown was built to isolate contamination in case of rain.

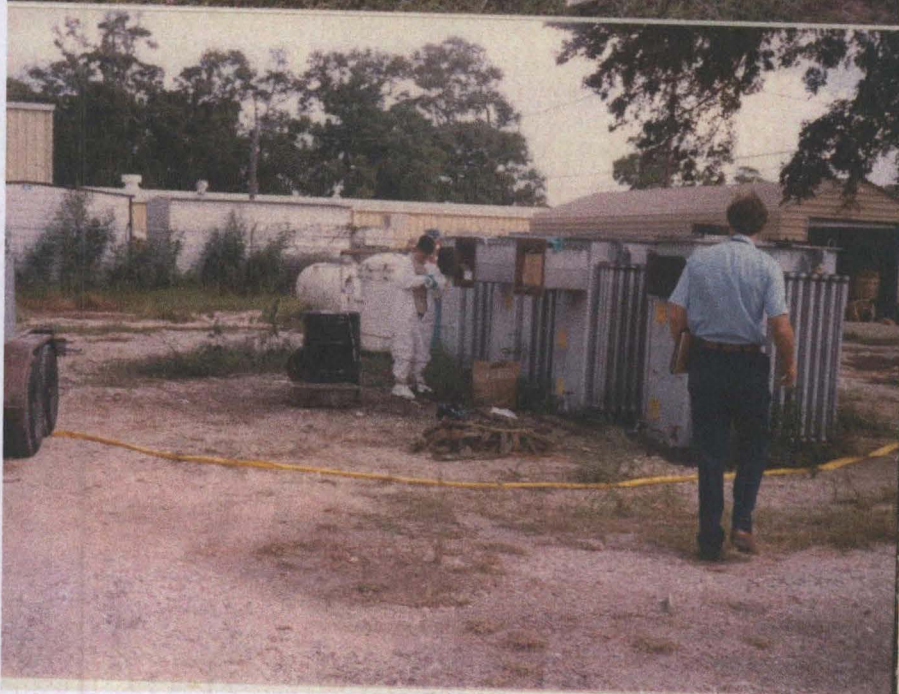
Photographer/Witness # 12

Comments: The area around the transformers in the parking lot received the PCB oil after spill occurred.

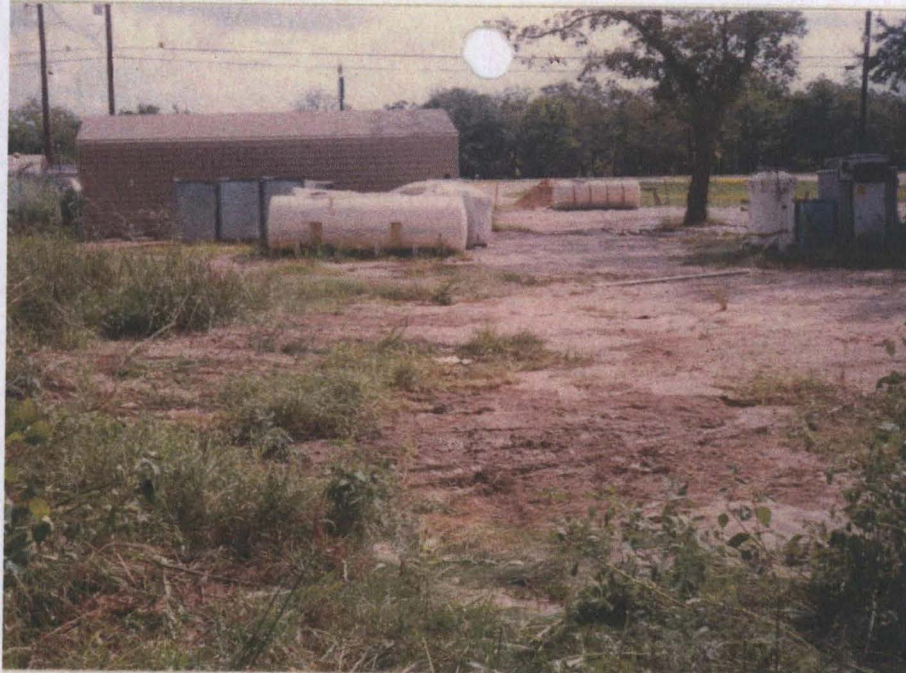
Photographer/Witness # 13

Comments: A photo of the northwest-
ern portion of BES parking lot where
spilled PCB oil spread. In the fore-
ground are some of the tanks that had
PCB oil.

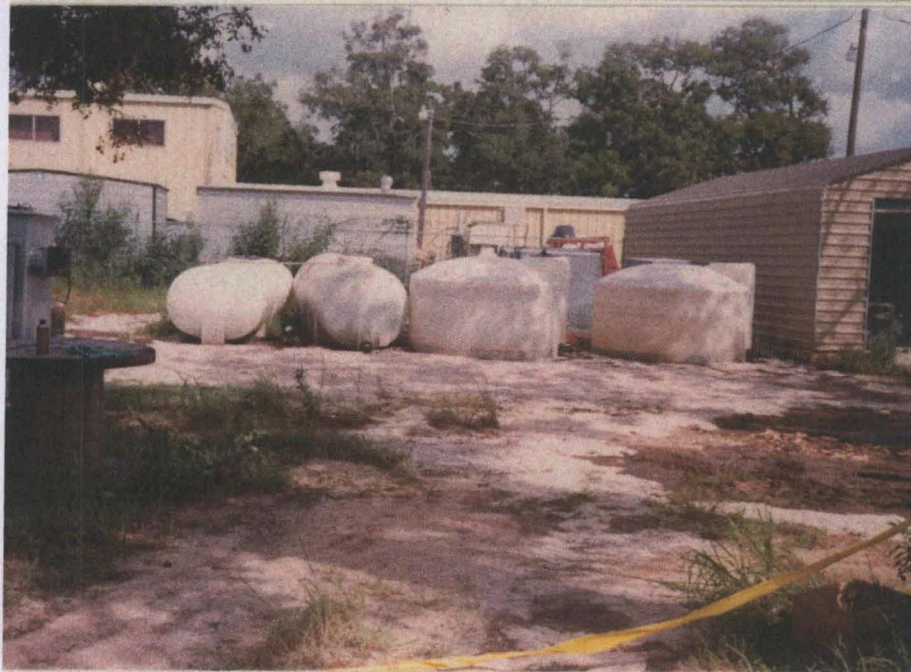
Photographer/Witness # 14

Comments: Spill area. Two skid
tanks on the right contain residual
PCB oil after spill occurred.

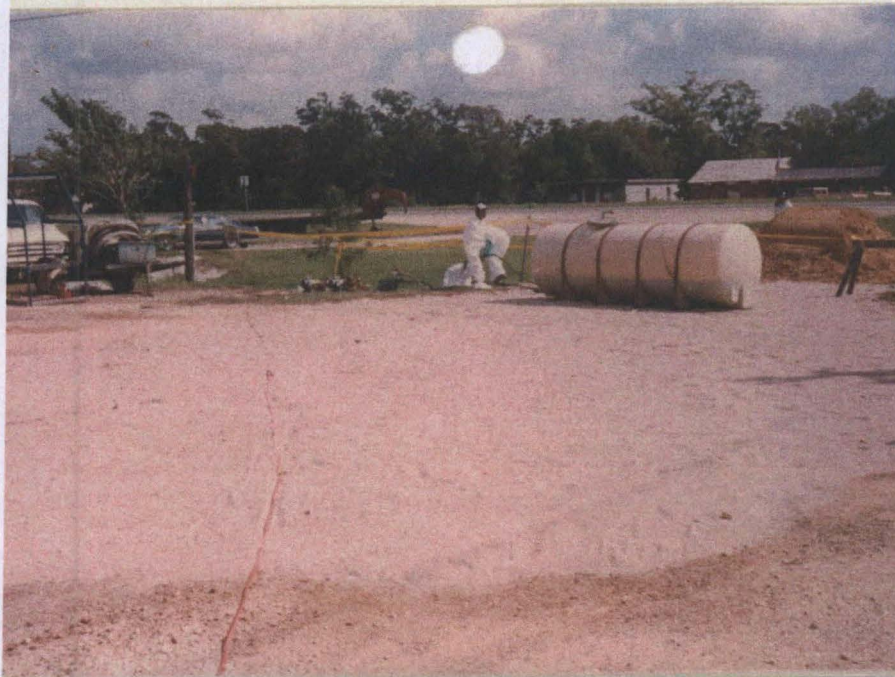
Photographer/Witness # 16

Comments: Spill area on the BES
parking lot covered with sand. In the
back, vacuuming of PCB oil from the off
site ditch in progress.

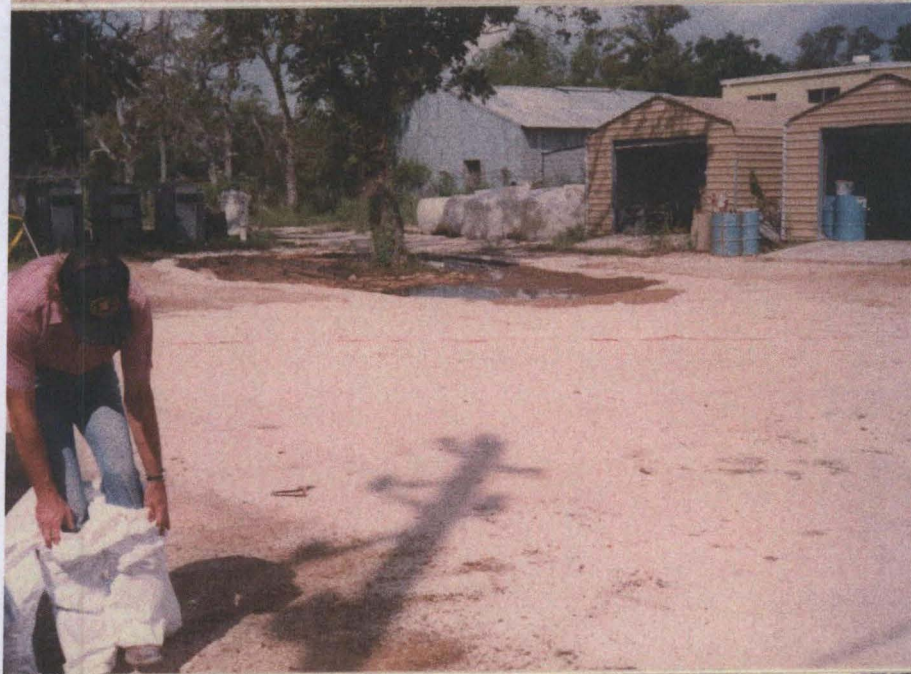
Photographer/Witness # 18

Comments: Metal containers that
store 55-gallon drums containing PCB
wastes on BES property.

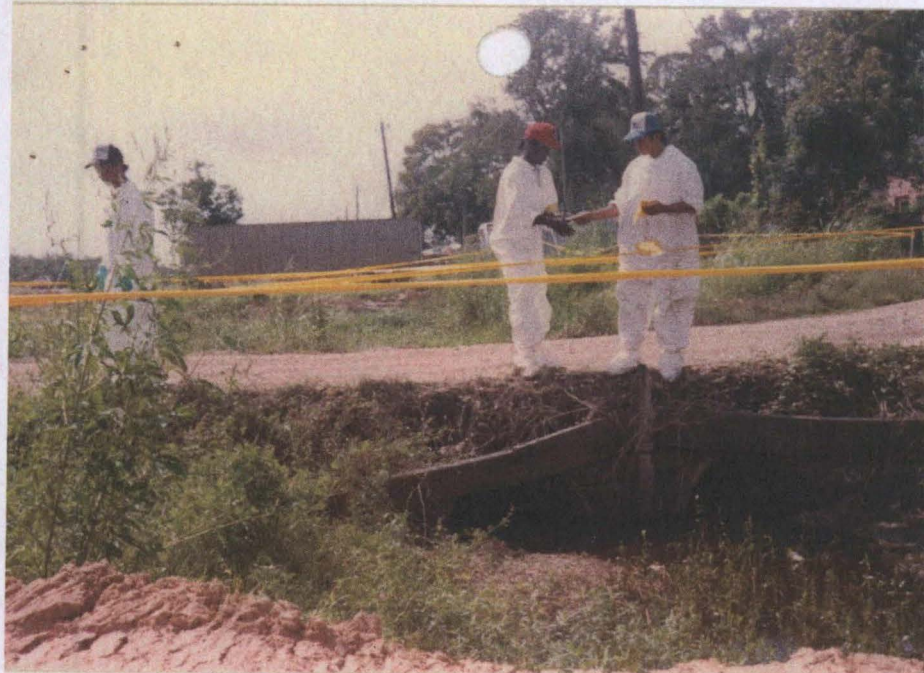
Photographer/Witness # 19

Comments: North end of the ditch
just in front of the earthen dam to
keep PCB contaminated oil and water
isolated.

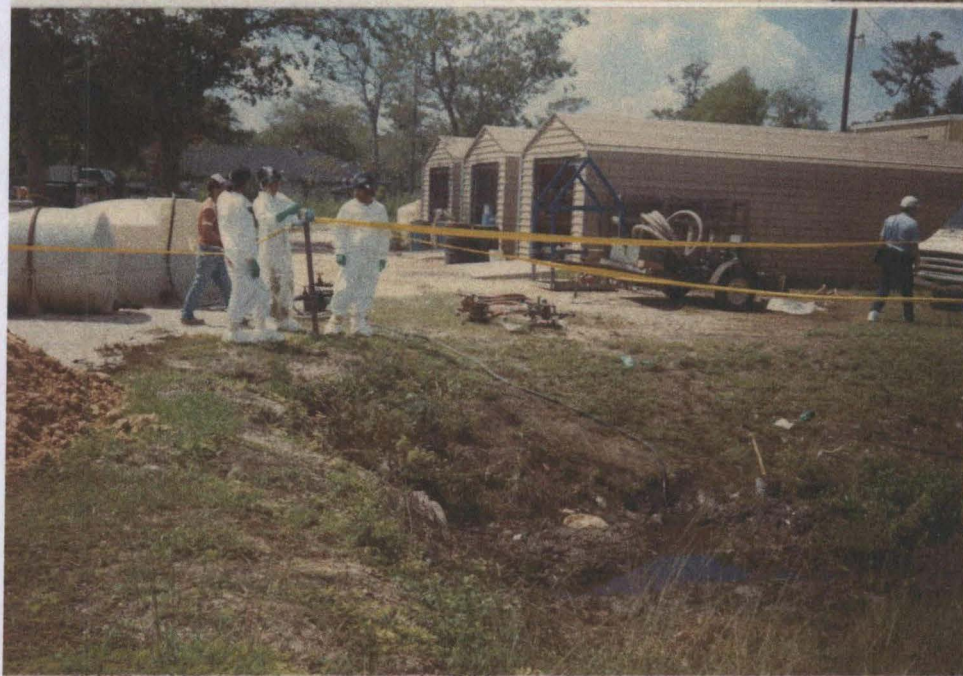
Photographer/Witness # 21

Comments: PRP begins removal of
oil from ditch.

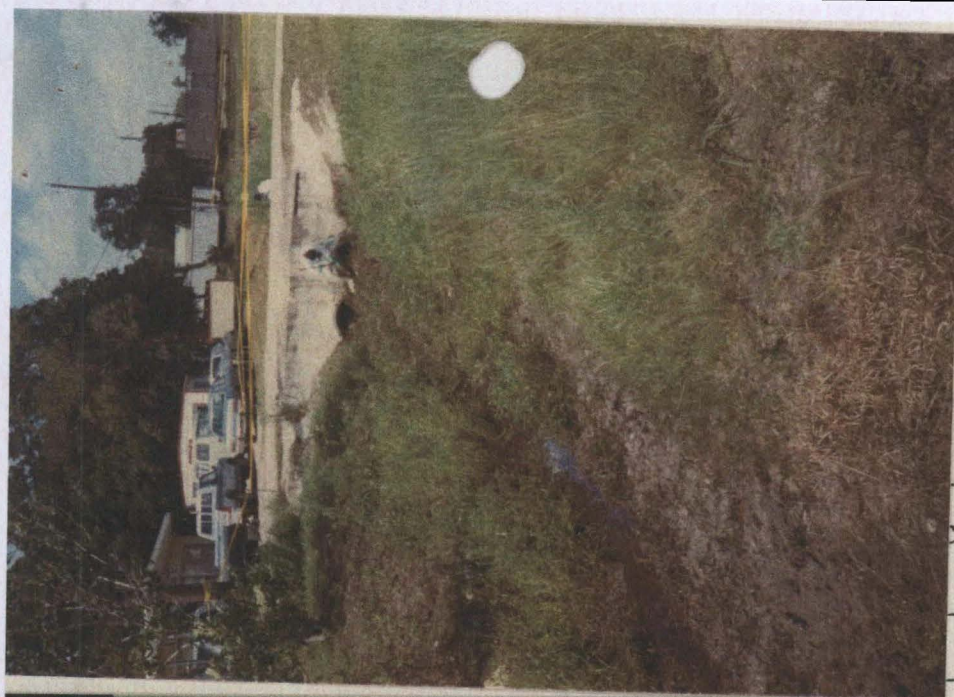
Photographer/Witness # 22

Comments: Workers in ditch wearing protective clothing.

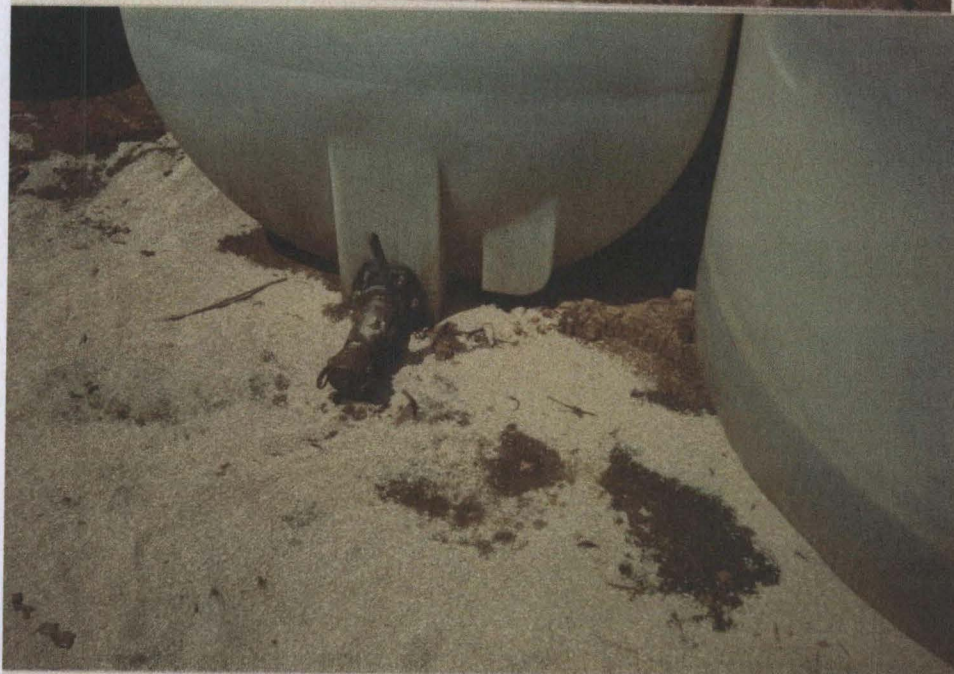
Photographer/Witness # 23

Comments: Absorbent material used to soak spilled oil on PRP site.

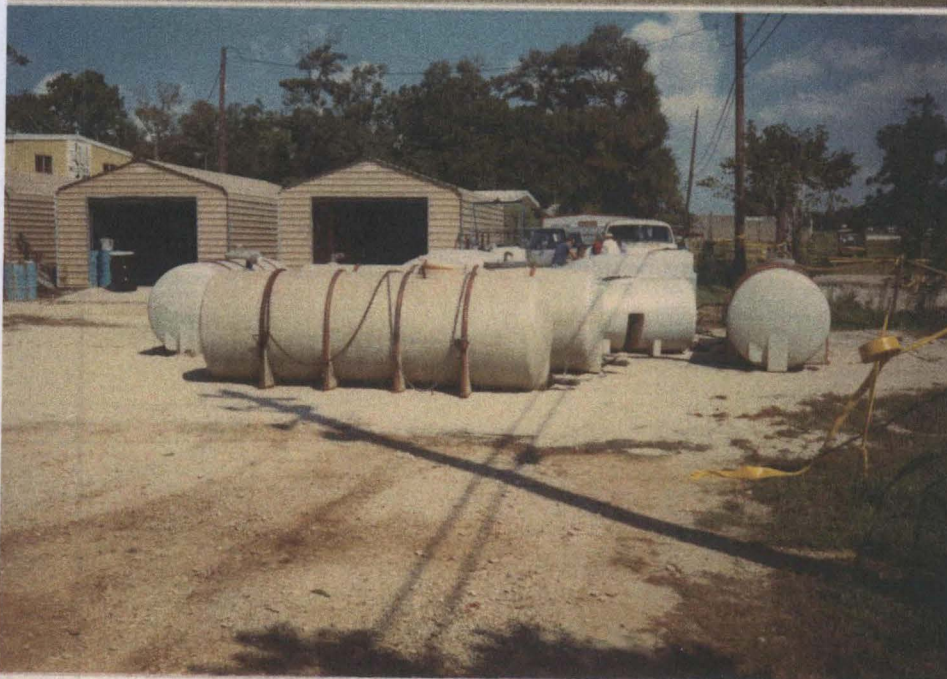
Photographer/Witness # 24

Comments: Tanks used to store liquids pumped from ditch

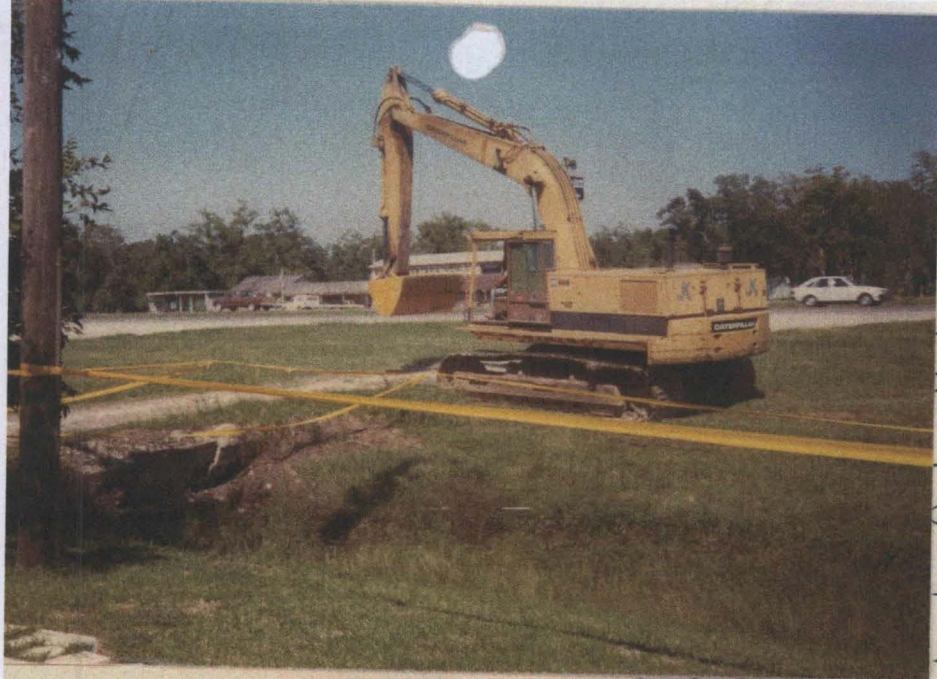
Photographer/Witness # 25

Comments: Trackhoe on scene 9/20/85.

Used for pushing liquid toward
vacuum trucks for collection.

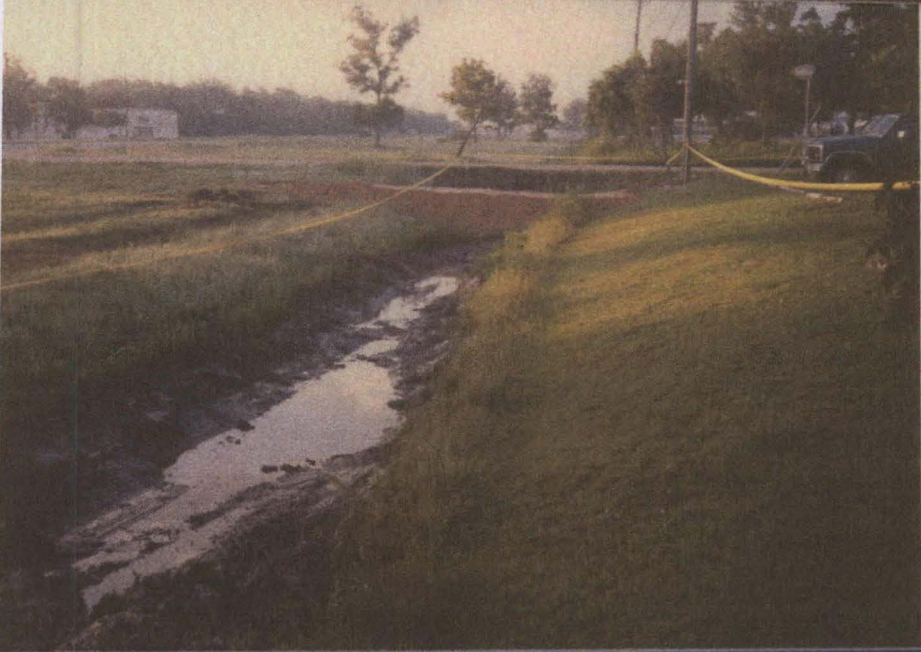
Photographer/Witness # 26

Comments: Water and oil remaining
in ditch after initial vacuum truck
operation on night of September 20th.

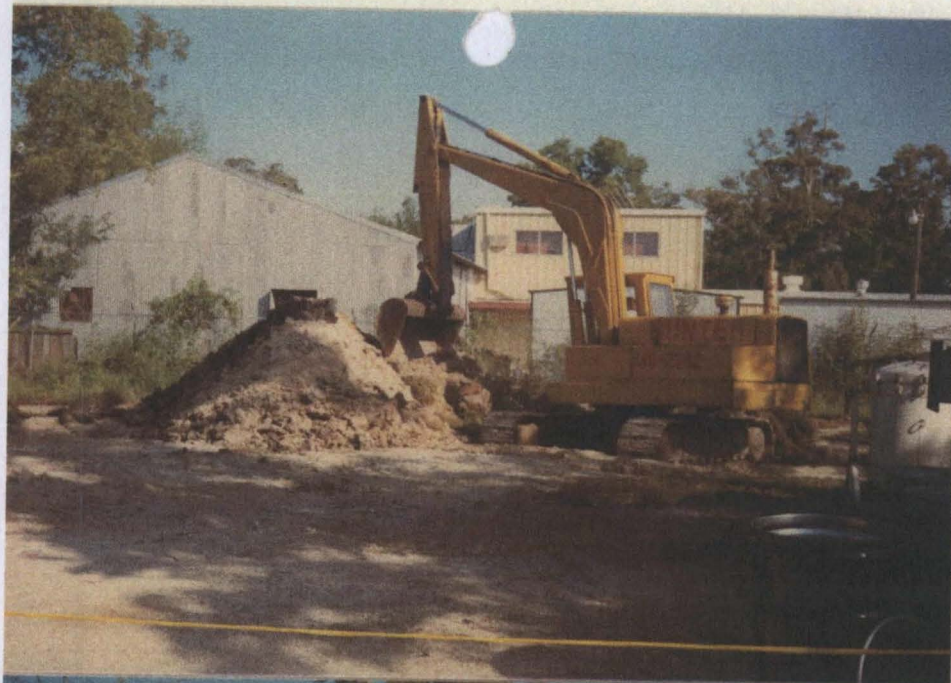
Photographer/Witness # 28

Comments: Second trackhoe scraping
soil on BES property

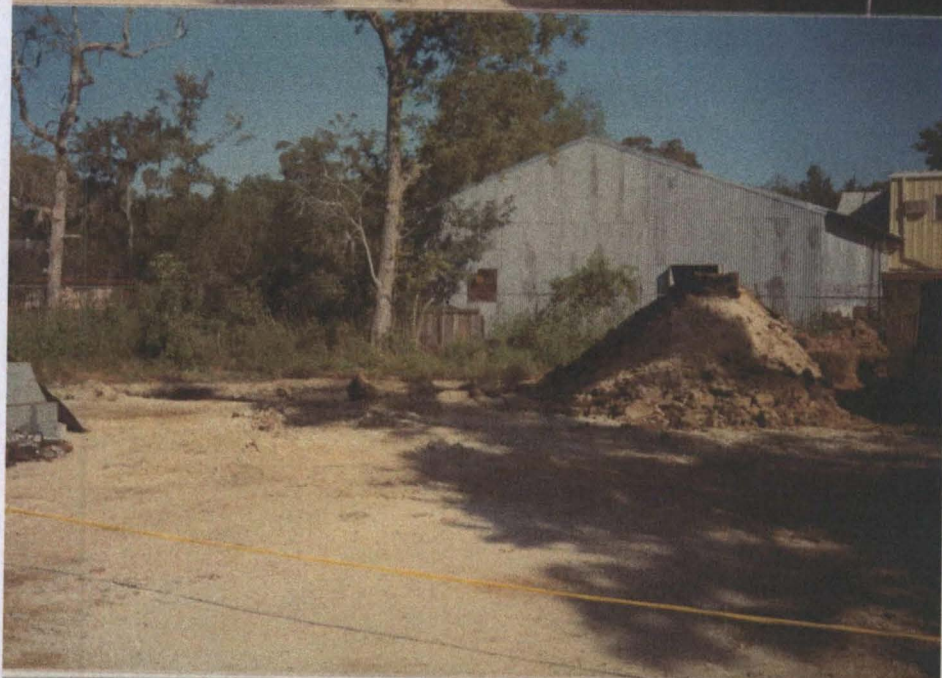
Photographer/Witness # 29

Comments: Soil scraped from BES
property and piled on site.

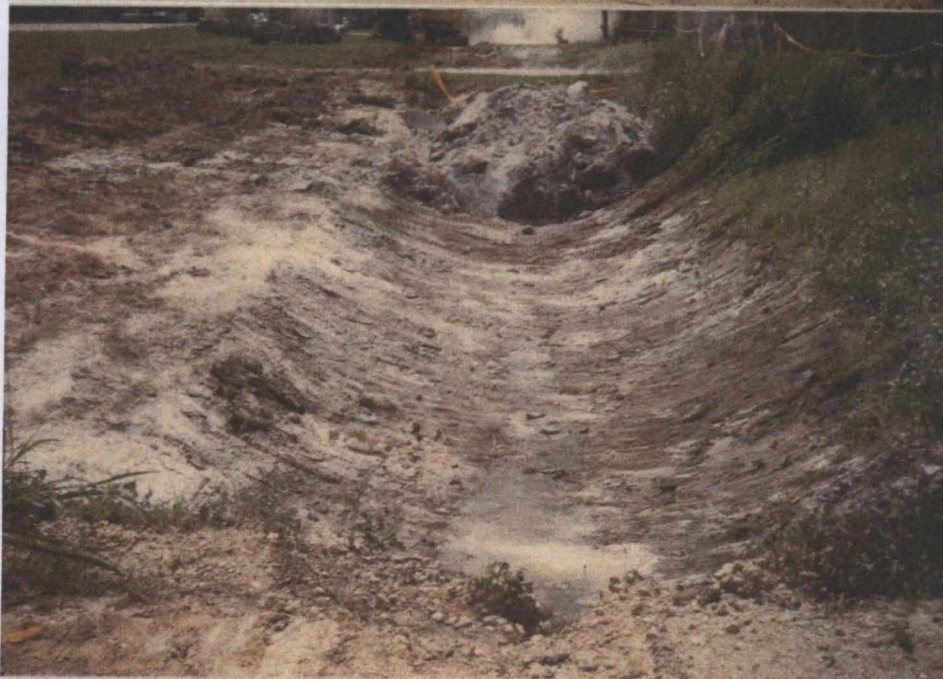
Photographer/Witness # 30

Comments: Lime applied to ditch and
mixed with soil. Trackhoe scraped
clean a section at a time. This re-
presents the first section scraped.

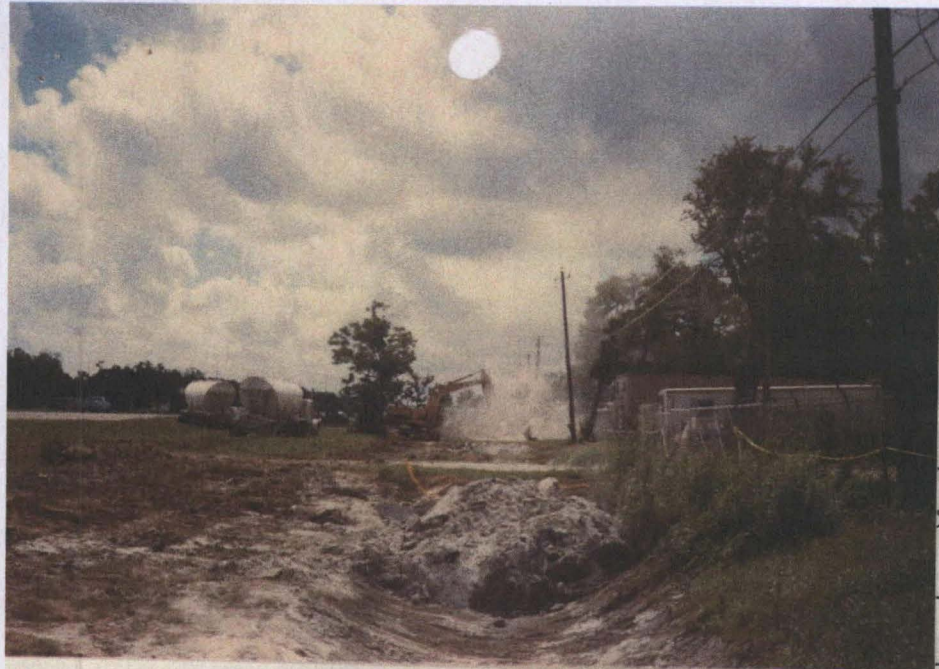
Photographer/Witness # 31

Comments: Trackhoe mixing lime
further down the ditch.

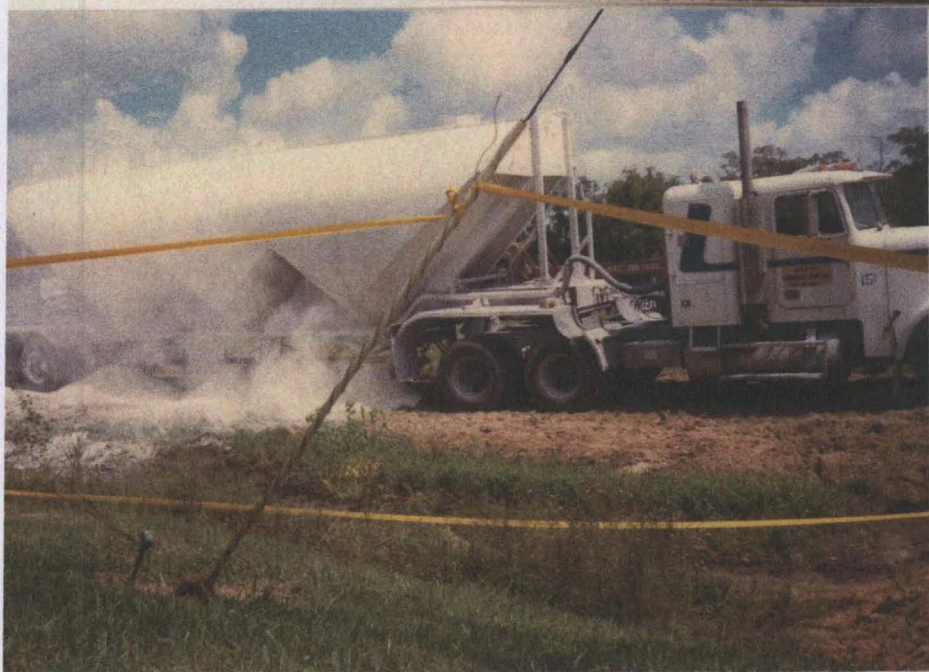
Photographer/Witness # 32

Comments: Liming process - unslaked
lime applied to side of ditch, is
then pushed in by bulldozer.

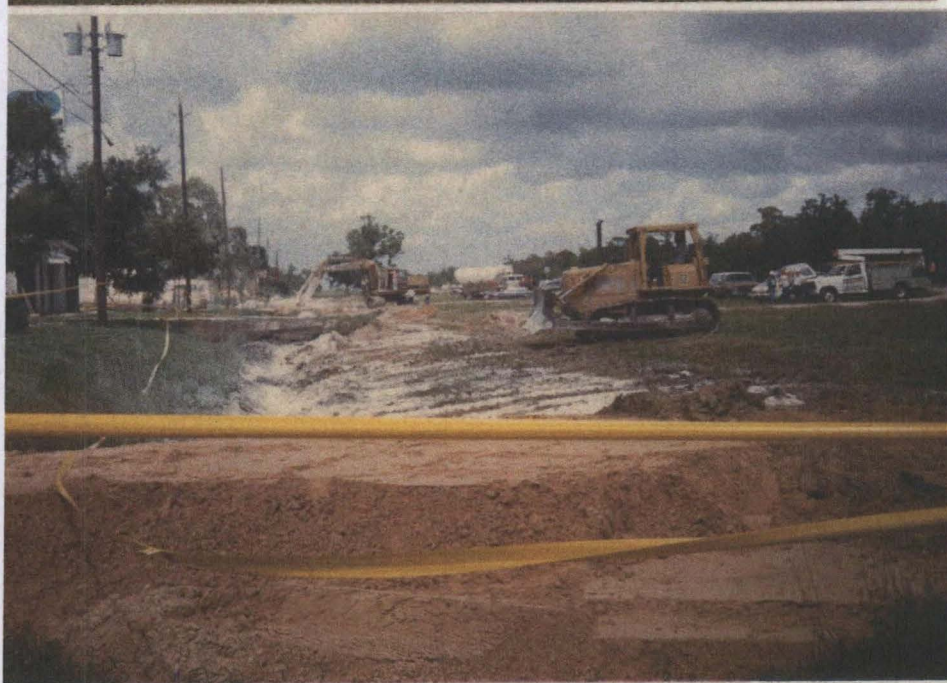
Photographer/Witness # 33

Comments: Bulldozer pushing lime
into ditch.

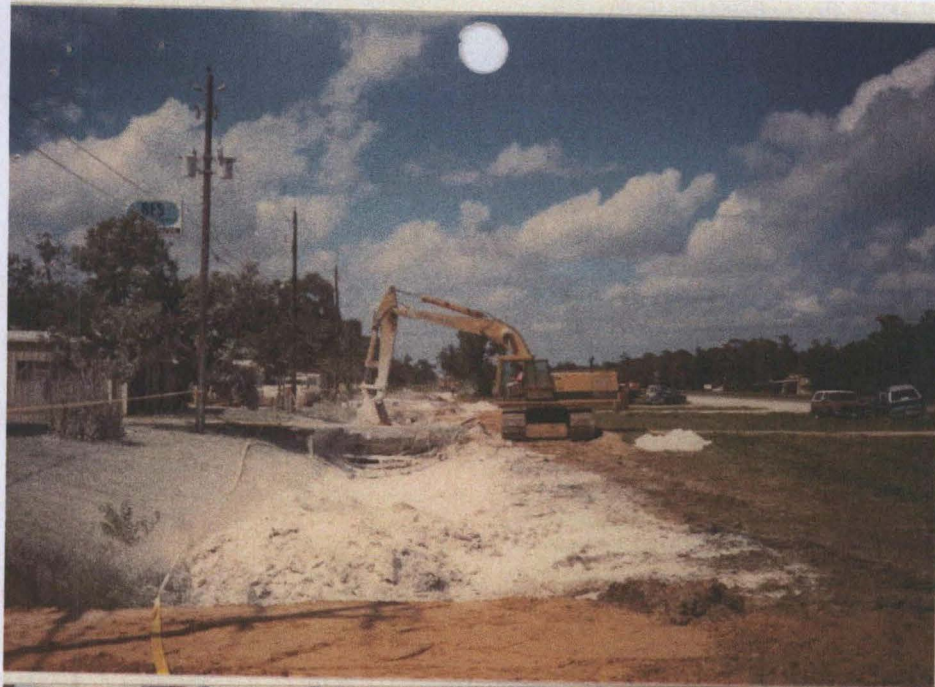
Photographer/Witness # 34

Comments: Beginning removal of seven culverts after mixing of lime was completed.

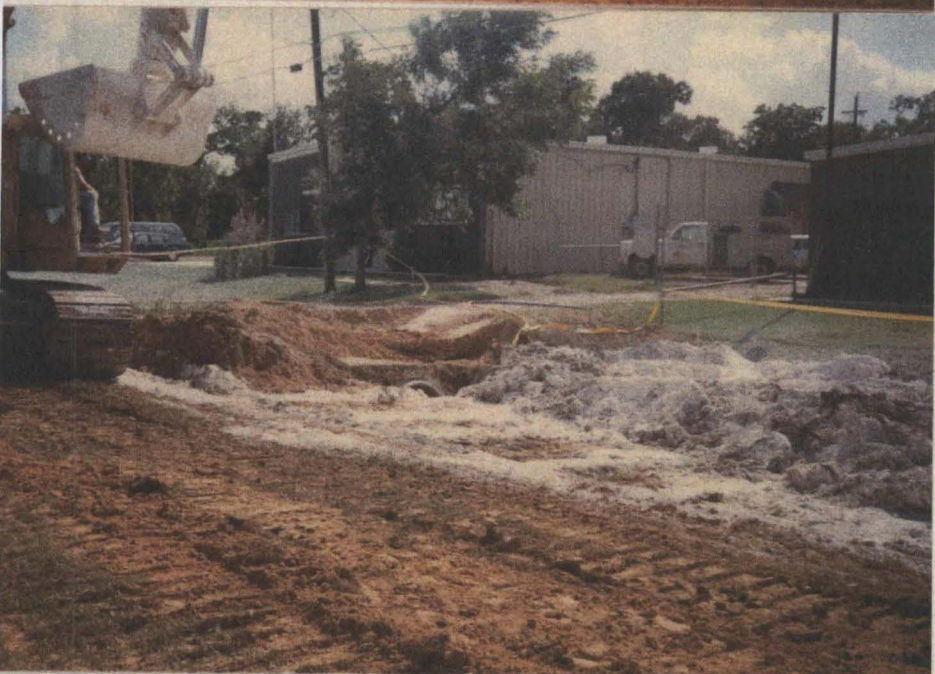
Photographer/Witness # 35

Comments: To remove culvert, top of culvert scraped as soil was not contained. Pipe was then broken and removed.

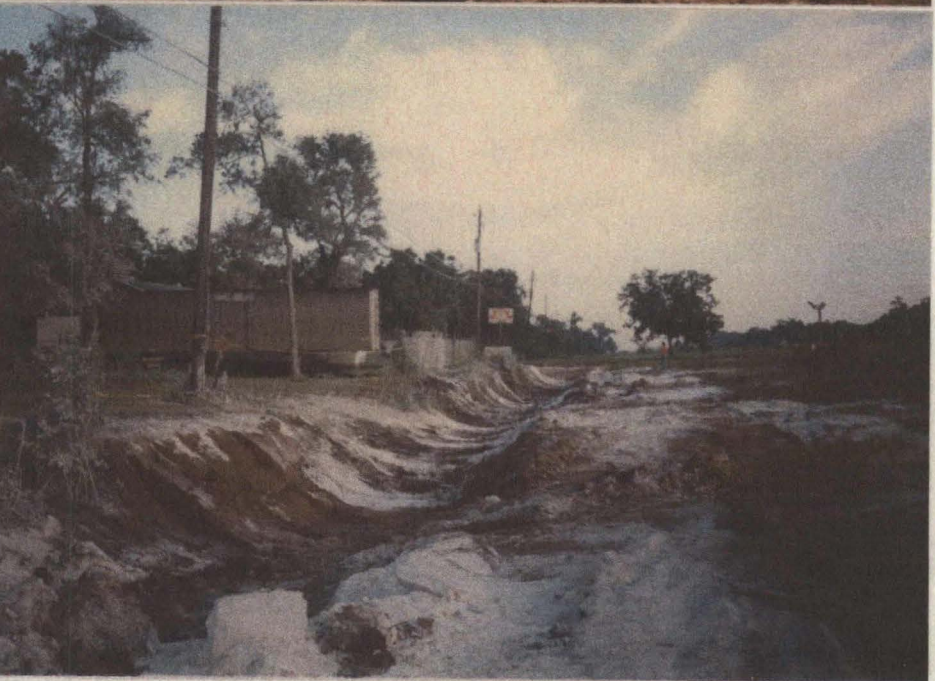
Photographer/Witness # 36

Comments: Cleaned portion of ditch Almost half through as of 0800 hrs. on 9/22.

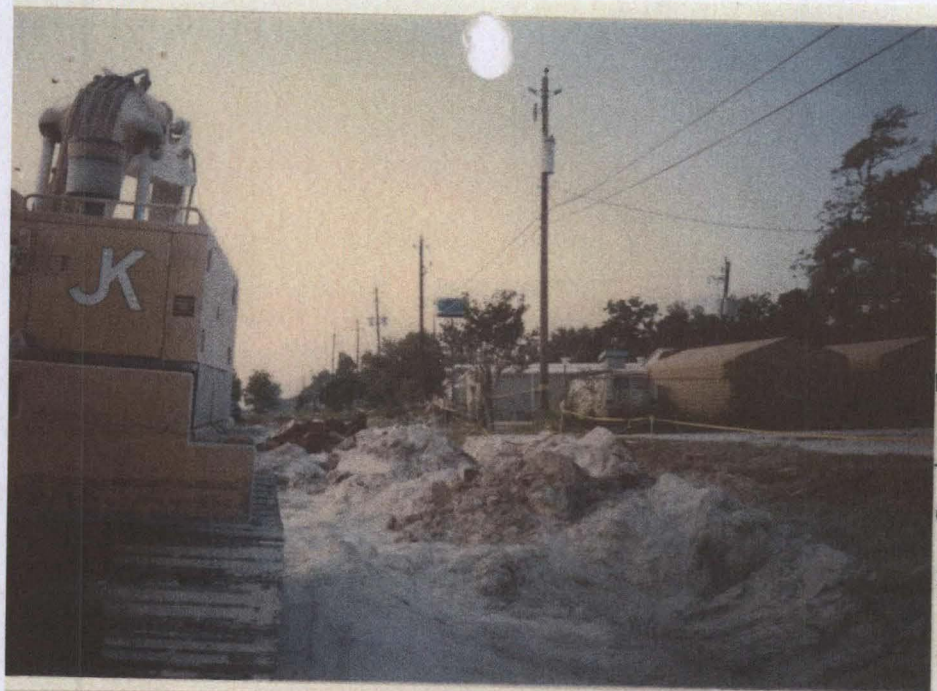
Photographer/Witness # 37

Comments: Portion of ditch re-
maining to be cleaned.

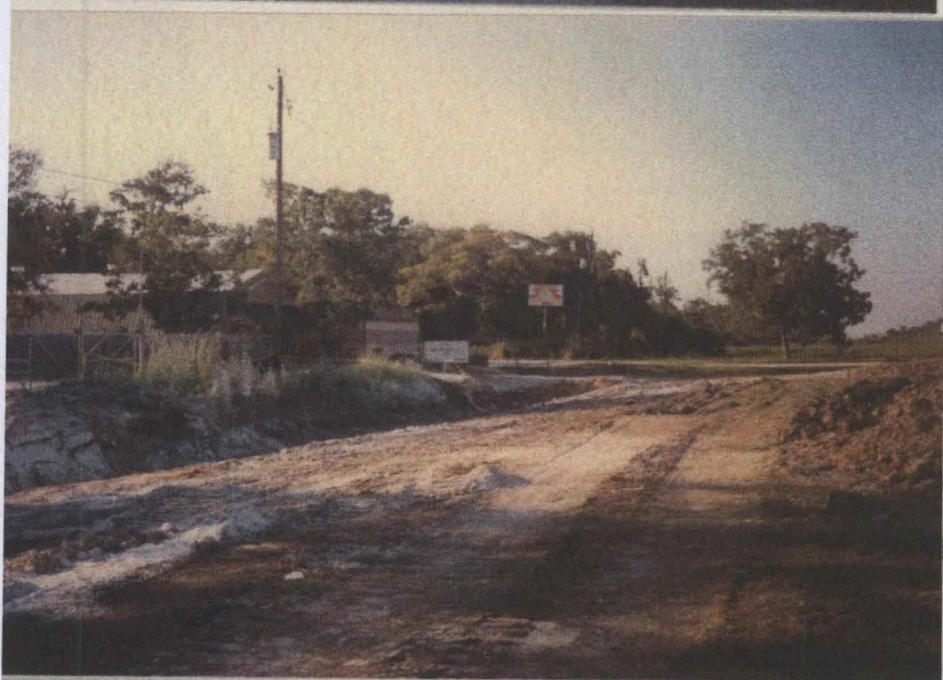
Photographer/Witness # 38

Comments: Ditch cleaned and side
scrapped to remove any soil contaminating
the side from trackhoe and trucks.

Soil to the right in photo is clean.

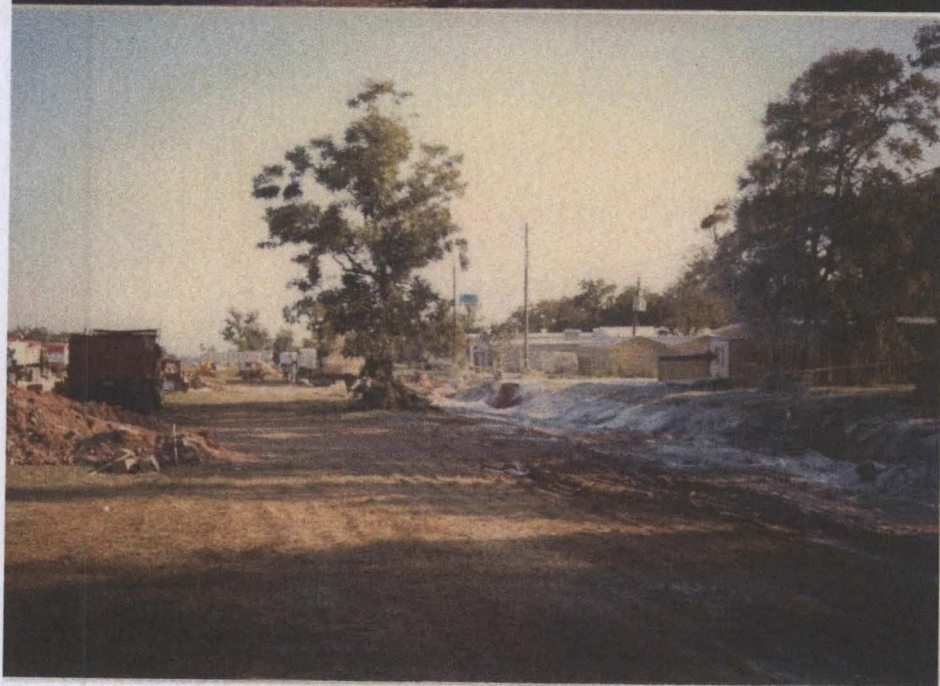
Photographer/Witness # 39

Comments: Loading trucks with the
contaminated soil.

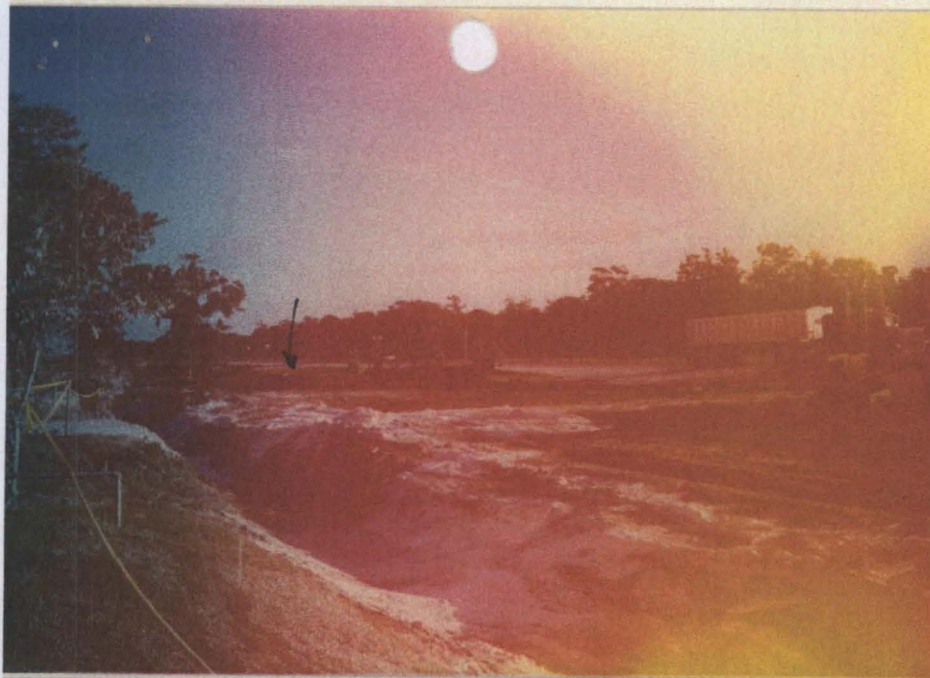
Photographer/Witness # 40

Comments: Plastic sheeting (arrow)
to line ditch in case of rain. Sheet
is 60 mil thickness, 34 feet wide &
600 feet long.

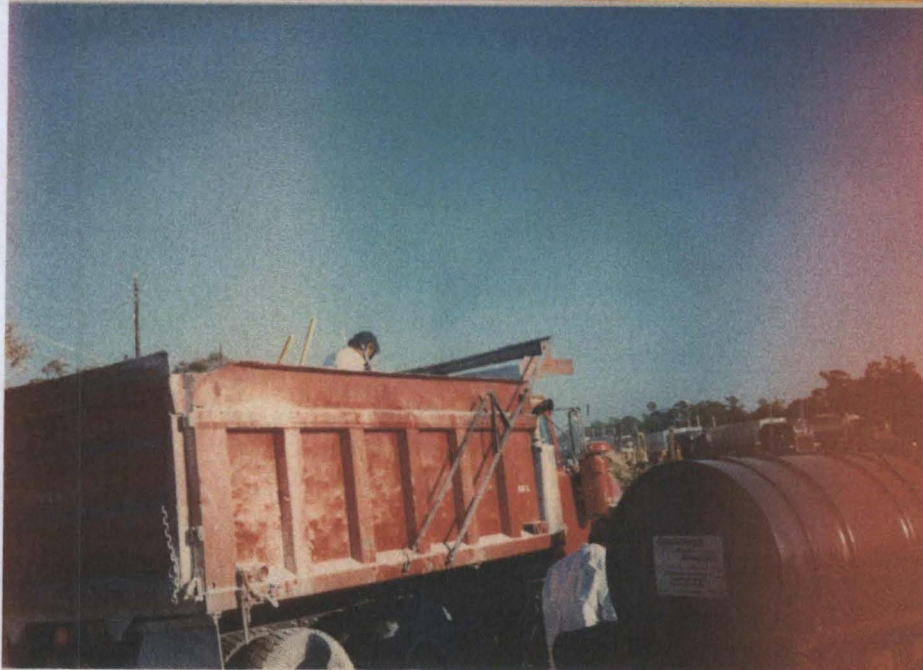
Photographer/Witness # 41

Comments: Decon of truck used to
pile ditch soil into single pile as
a contingency against heavy rain.

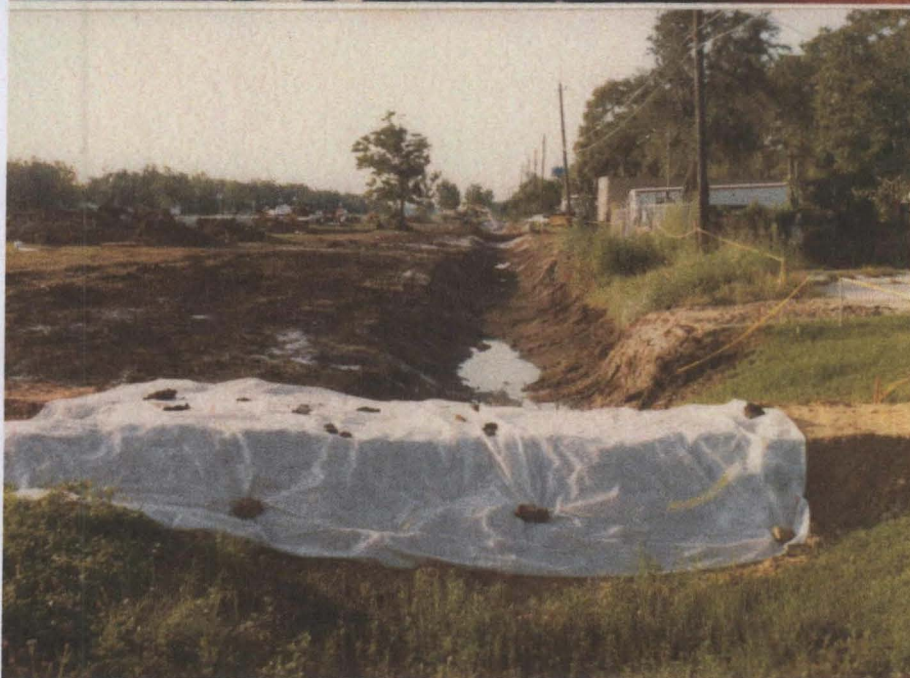
Photographer/Witness # 42

Comments: View of ditch after
initial cleanup. Rain shower night
of 9/23 resulted in small amount of
water in ditch.

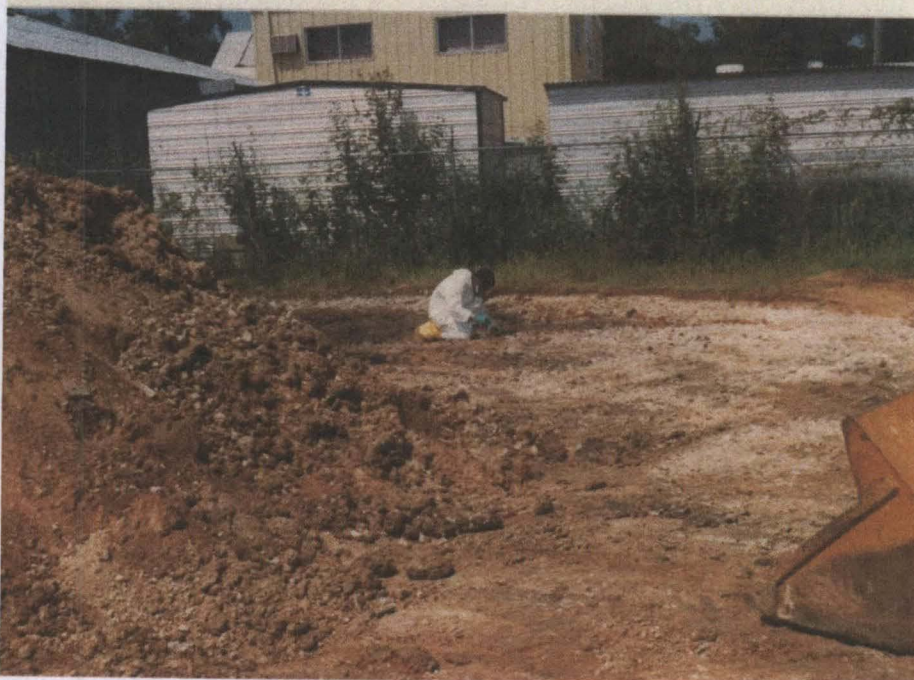
Photographer/Witness # 45

Comments: Protective clothing worn
when sampling soil. This was the
second sampling on site.

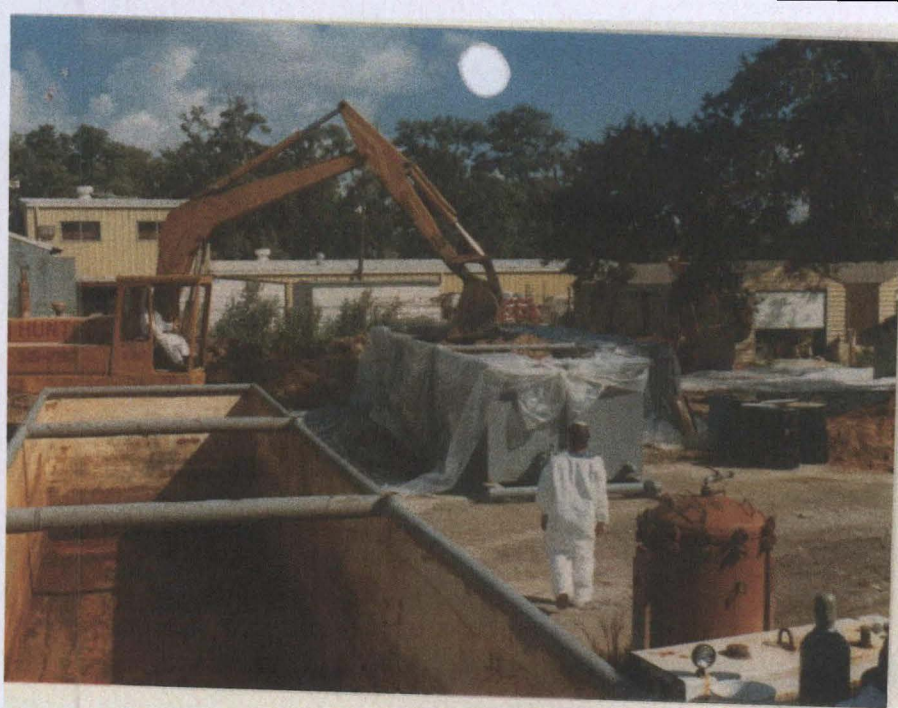
Photographer/Witness # 46

Comments: PCB contaminated soil
piled on BES property being loaded
into mud tanks for temporary storage.

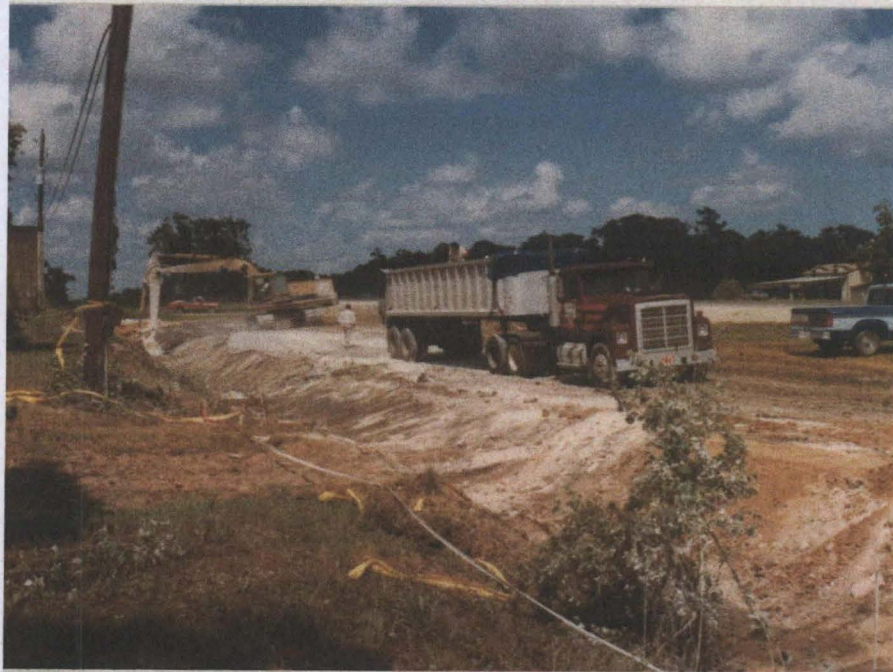
Photographer/Witness # 47

Comments: Recond excavation of ditch
to remove hot spots.
